# Texas Community Doubles Water Supply by Lining Failed Reservoir

A 45-acre water reservoir in Robinson, Texas stood empty for 17 years due to failure of the existing clay liner. Today, the reservoir is fully operational and is meeting the increasing water demands of this rapidly growing community thanks to the installation of a high quality EPDM geomembrane.

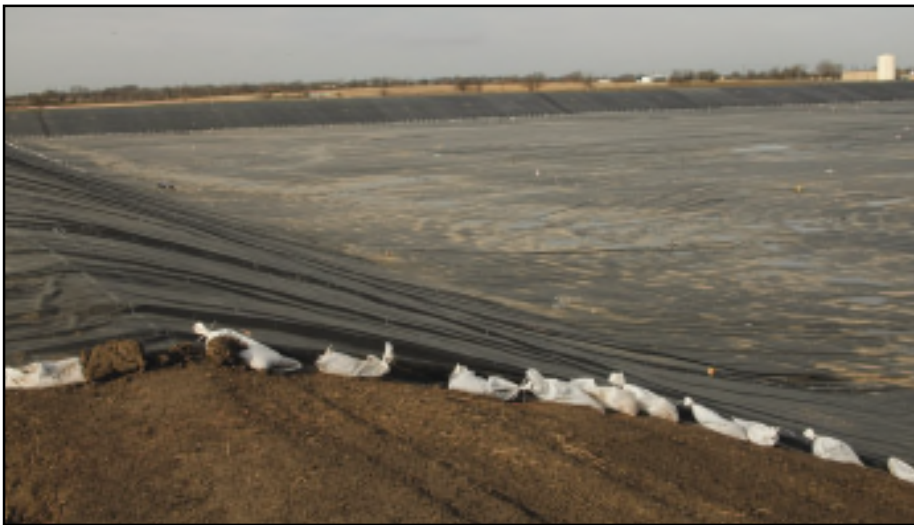
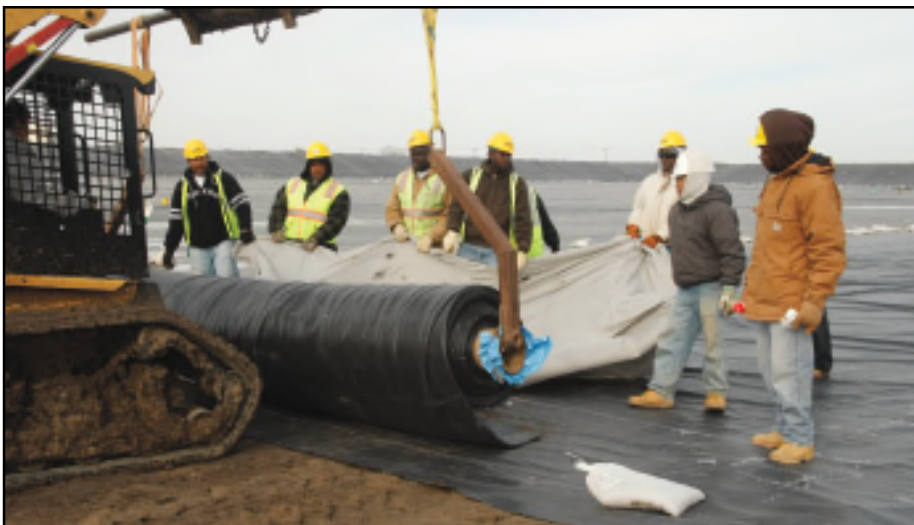
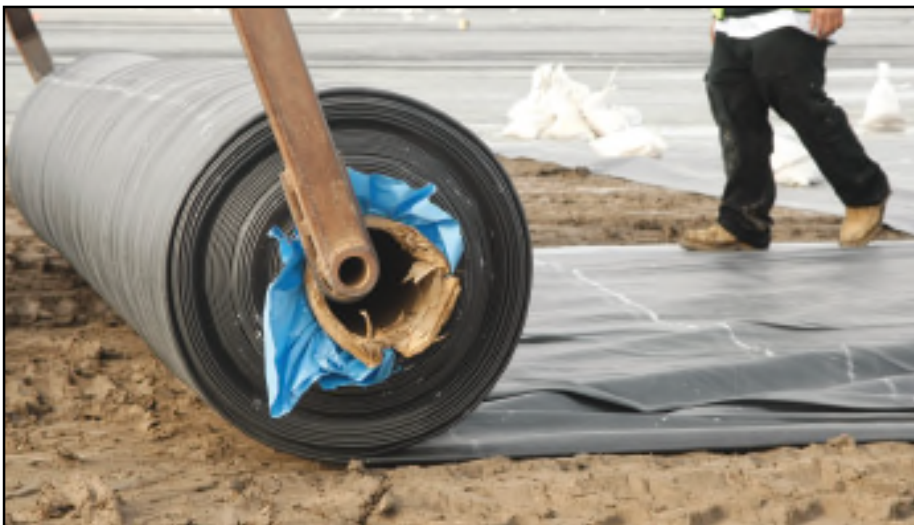
Each EPDM panel seam was prepared with a primer and allowed to flash off before putting down Firestone QuickSeam™ Tape and rolling it out to ensure a watertight seam. Pipe boots were also installed, where necessary, and a batten strip was mechanically attached around a piece of equipment that sits on the reservoir floor to measure water depth. A skid steer was outfitted with a spreader bar and the geotextile fabric was unrolled by hand and unfolded in slightly overlapping sections down the 3:1 slopes. As each section was finished, another crew followed with the EPDM panels using the same system for unrolling the 50-foot by 200-foot panels.

On January 28, 2008, GSI began the lining system installation. The crew started by installing a non-woven geotextile fabric underlayment around the entire perimeter of the reservoir from the trench at surface level down to 10 feet out from the slope toe, according to Dan Vogt, field superintendent for GSI. A skid steer was outfitted with a spreader bar and the geotextile fabric was unrolled by hand and unfolded in slightly overlapping sections down the 3:1 slopes. As each section was finished, another crew fol-

lowed with the EPDM panels using the same system for unrolling the 50-foot by 200-foot panels. The panels were installed over the underlayment fabric as well as the reservoir floor.

Each EPDM panel seam was prepared with a primer and allowed to flash off before putting down Firestone QuickSeam™ Tape and rolling it out to ensure a watertight seam. Pipe boots were also installed, where necessary, and a batten strip was mechanically attached around a piece of equipment that sits on the reservoir floor to measure water depth.
